Manhole Inspection Summary

Manhole # S29I__042MH

Location Address: **121 S.Fremont Ave.**

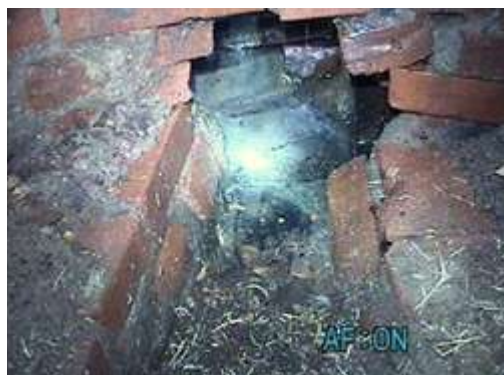
Defect 3

Condition: ☐ Sound ☐ Cracked ☐ Root Intrusion ☒ **Loose Brick** ☐ Deteriorated

barrel loose bricks (hole in barrel at 3 o'clock pipe)

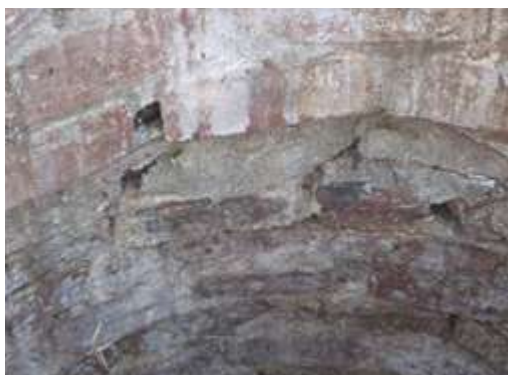
Defect 3

Condition: ☐ Sound ☐ Cracked ☐ Root Intrusion ☒ **Loose Brick** ☐ Deteriorated

missing brick and mortar at corbel

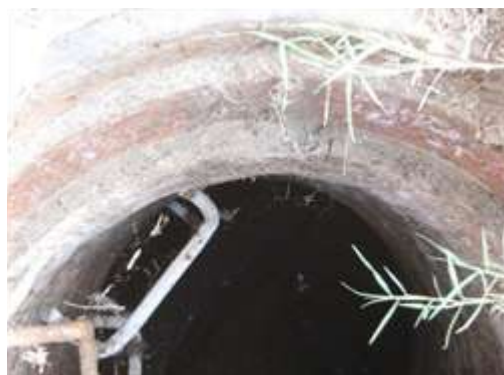
Defect 1

Offset: **1** (in.)

frame offset

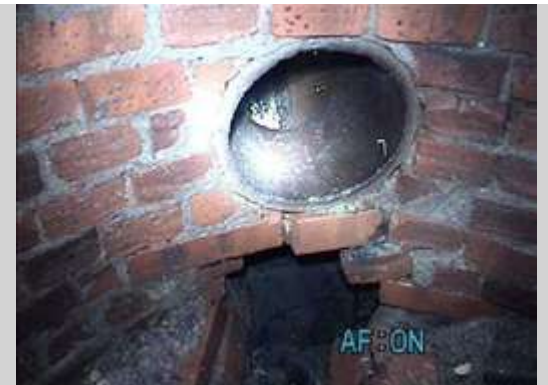
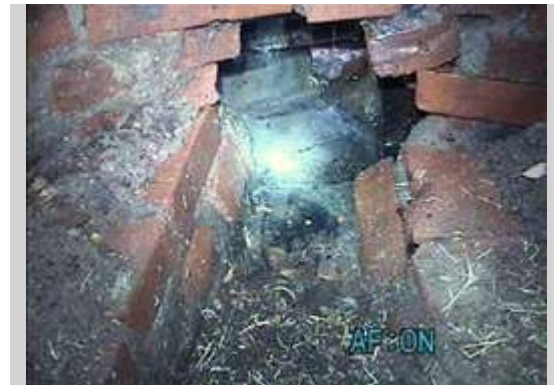
3 O'Clock Inflow

Pipe Height: **8.4** (in.) Rod and Bar (Angled)
Pipe Material: **Clay** ☐ Pipe Lined
Invert Depth: **10.76** (ft.) Flow Characteristics: **None**
Deposits: ☒ None ☐ Mud ☐ Sludge ☐ Debris ☐ Grease
Silt Depth: **0** (in.) Deposits Extent:
Infiltration: **None** Pipe Seal Cond: **Broken**
